FINAL ~~DRAFT~~ TECHNICAL MEMORANDUM

PHASE II BASELINE ECOLOGICAL ASSESSMENT SUMMARY OF RESULTS KANE AND LOMBARD SUPERFUND SITE BALTIMORE, MARYLAND

Harding Lawson Associates
Philadelphia, Pennsylvania

STORMWATER DRAINAGE SYSTEM INVESTIGATION SUMMARY OF RESULTS

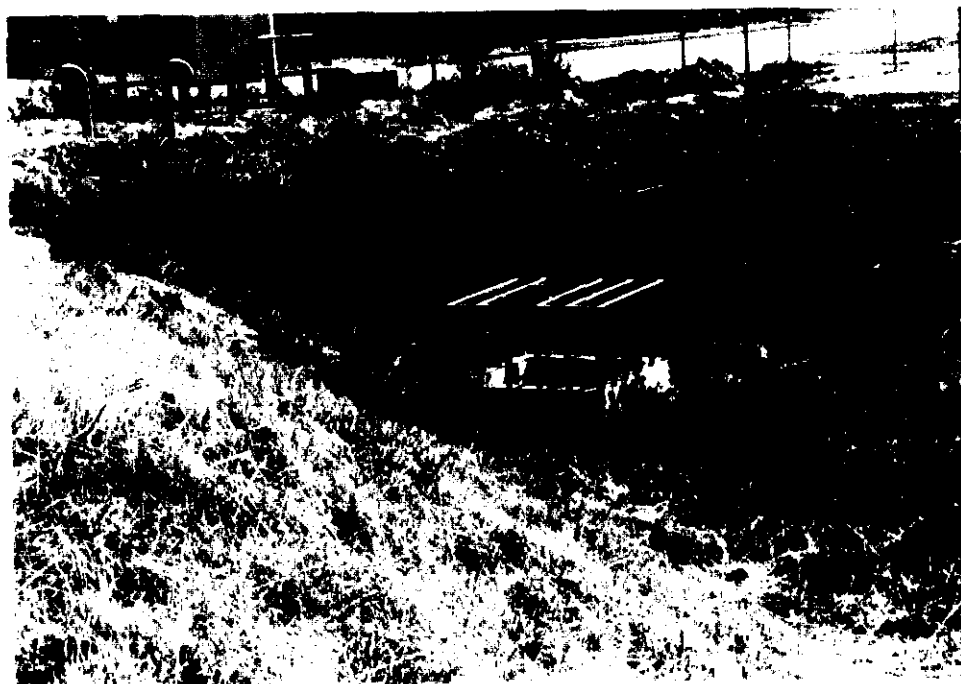
PHOTOGRAPH F-6

Runoff from the eastern portion of the Superfund Site is captured by a swale on the Superfund Site lined with riprap and channeled into stormwater catch basin in the northeast corner of the Superfund Site (Figure F-6, Photograph F-6). The water collected in this catch basin enters a 36-inch reinforced concrete pipe (RCP) which drains in a northeastern direction.

Stormwater catch basin in northeast corner of the Superfund Site
